Re: Notice of Violation
Compliance Evaluation Inspection
ILD006263073

RCRA COMPLIANCE EVALUATION INSPECTION REPORT

SITE NAME: Knapheide Manufacturing Company

DATE OF INSPECTION: March 9th, 2016

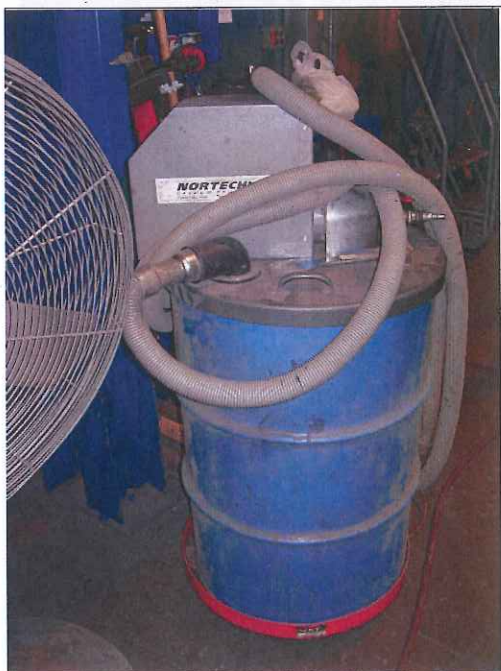
Picture #: 1
[DSCN0027]
Date: March 9, 2016
Photographer: Dan Chachakis
Location: KMC cleaning station
Subject: Vacuum

We began at the box building area, and we were able to observe the miscellaneous lid building area. We moved through the station 4 welding area, the floor station, and the assembly area where sides were attached to the floor. We moved through Final Station 1 and Final Station 2, then the cleaning station to the main plant. I observed, and took a picture of, a vacuum (Picture 1). Mr. Wingerter stated the vacuum secures grinding dust from steel grinding operations.

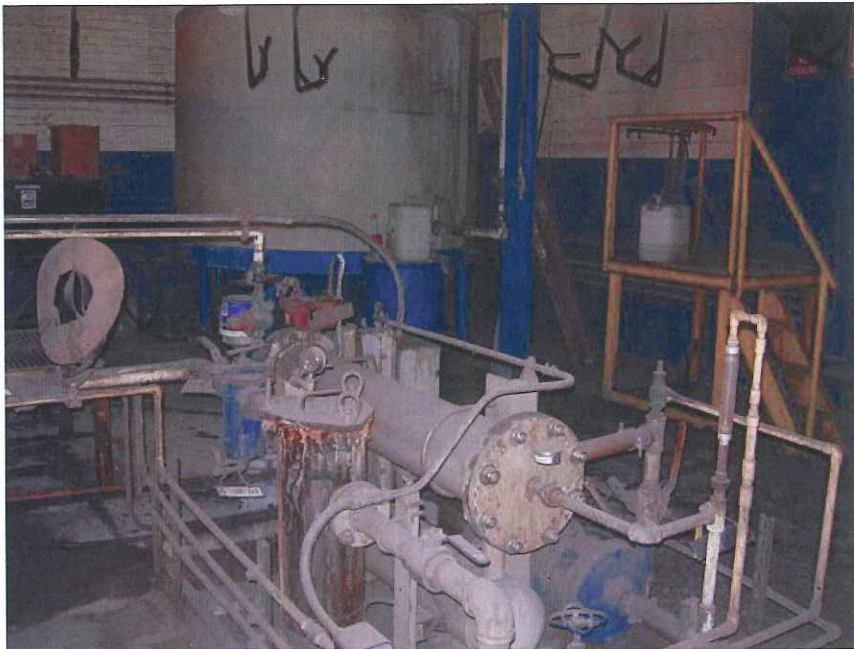
Picture #: 4
[DSCN0030]
Date: March 9, 2016
Photographer: Dan Chachakis
Location: Wastewater Treatment System Area
Subject: Wastewater Treatment System

I observed that the large tank in Picture 4 was not labeled or marked with the contents of the tank. Mr. Ott stated that wastewater is treated and released to the city system. However, he stated that occasionally KMG empties the bottom of the tank into totes and ships the totes to a

At the time of the inspection, KMC was unable to provide a record documenting the hazardous waste determination for the waste from the bottom of the wastewater treatment tank that is placed in totes and shipped to a wastewater treatment facility.

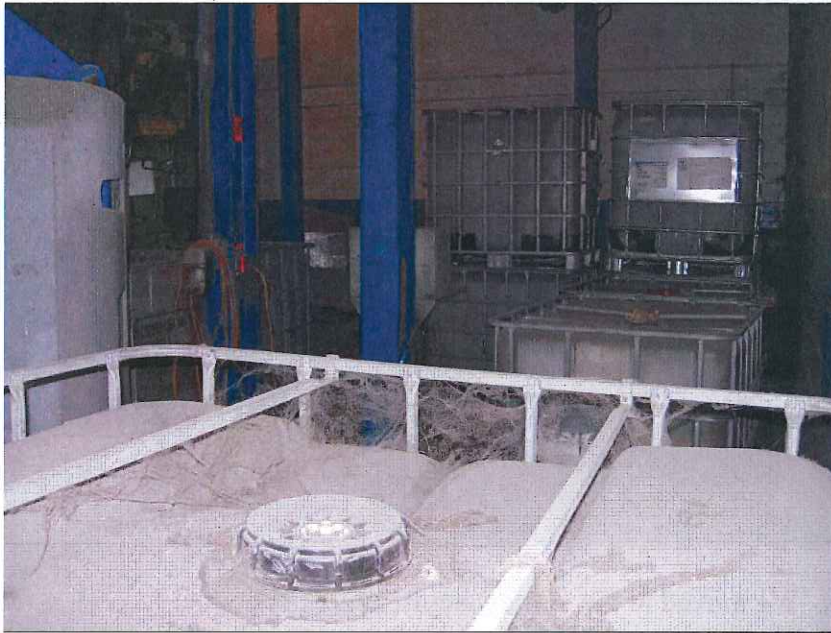
Picture #: 5
[DSCN0031]
Date: March 9, 2016
Photographer: Dan Chachakis
Location: Wastewater
Treatment System Area
Subject: Totes

second wastewater treatment system. I observed, and took a picture of, eight totes with material in the totes at the time of the inspection (Picture 5).

I observed that the totes were not labeled or marked with the contents of the totes; I recommended that all containers, totes and tanks be marked or labeled with the contents of the containers. We moved to the prime booth.

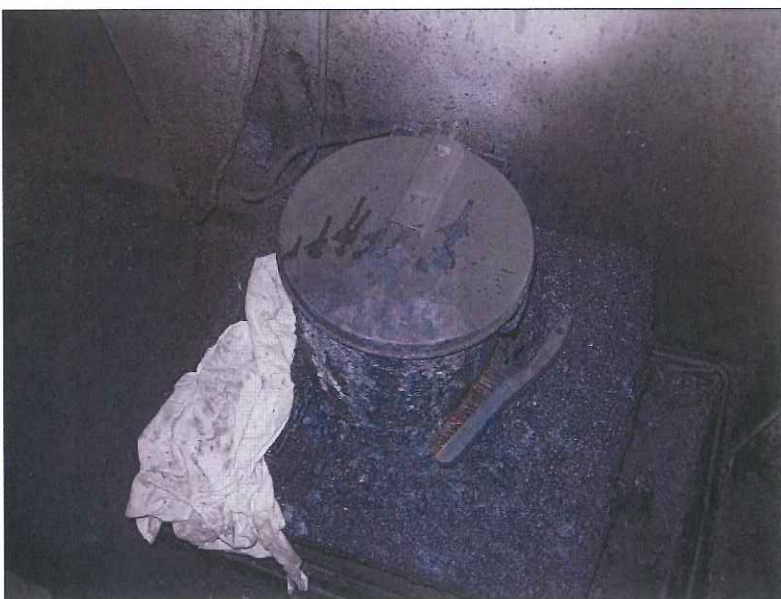
Picture #: 7
[DSCN0033]
Date: March 9, 2016
Photographer: Dan Chachakis
Location: Top Coat Paint Booth
Subject: Container

I observed that the container in Picture 7 had a cover; I opened and it was approximately 75% full. The container in Picture 8 did not have a cover, and I observed that there was approximately two inches of material covering the bottom of the bucket. I observed that neither container was marked or labeled with the contents of the container. I observed that the location of the containers were in the same areas as the containers in the Prime Paint Booth. We moved to the solid waste storage area.

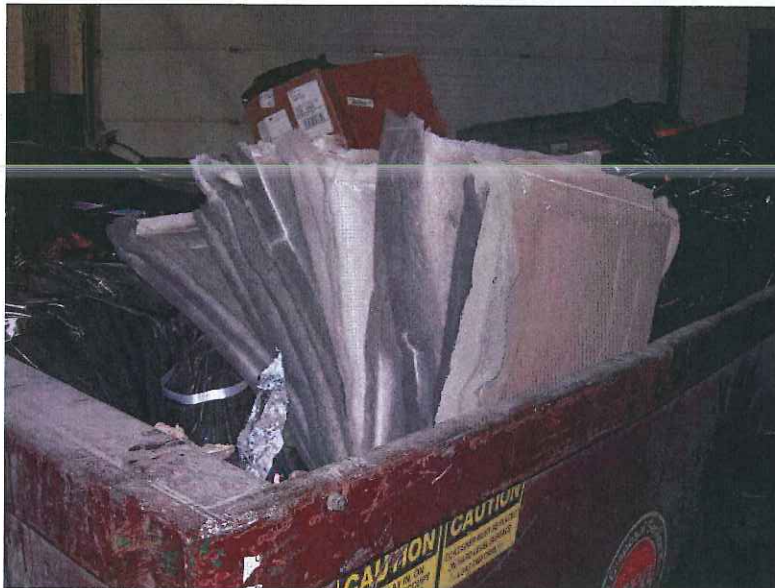
Picture #: 9
[DSCN0035]
Date: March 9, 2016
Photographer: Dan Chachakis
Location: Solid Waste Storage Area
Subject: Filters in a dumpster

Solid Waste Storage Area: I observed, and took a picture of, filters in a dumpster (Picture 9).

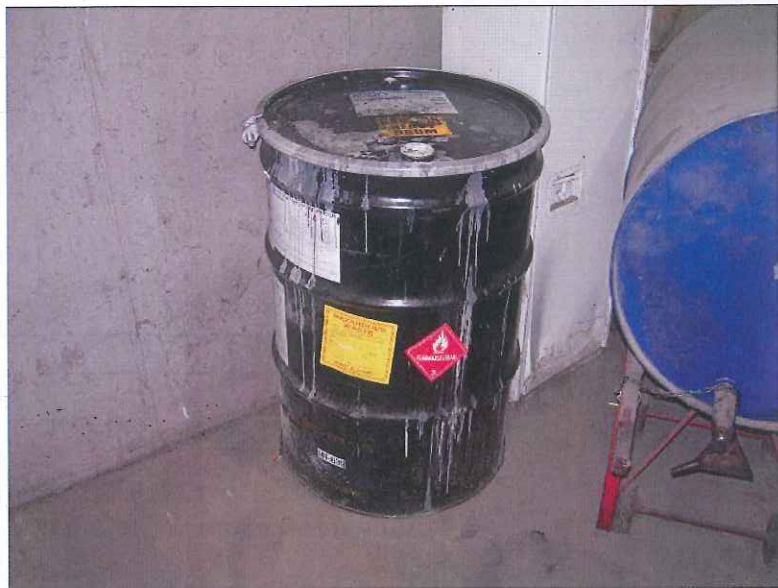
Picture #: 10
[DSCN0036]
Date: March 9, 2016
Photographer: Dan Chachakis
Location: Hazardous Waste Storage Area
Subject: Container 1

I observed, and took a picture of, a container with a hazardous waste label, marked with the words, "D001" and "Ethyl Ketone, Toluene" (Picture 10, Container 1). I observed that the label was not marked with the accumulation start date, and I took a Picture of the label (Picture 11).

At the time of the inspection, KMC maintained two 55-gallon drums containing D001 characteristic hazardous waste that were not marked with the date upon which each period of accumulation of hazardous waste began. See page 9 and Pictures 10 and 11, and page 10 Pictures 12 and 13, of the enclosed inspection report.

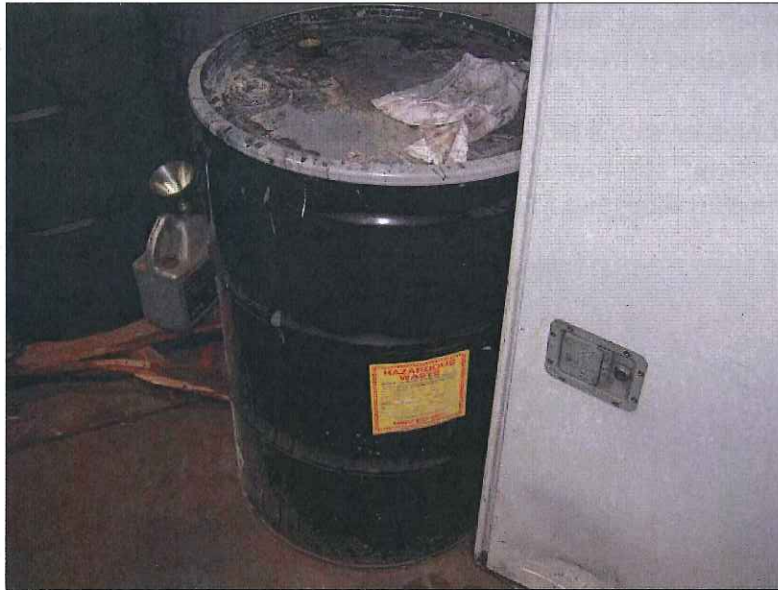
Picture #: 12
[DSCN0038]
Date: March 9, 2016
Photographer: Dan Chachakis
Location: Hazardous Waste Storage Area
Subject: Container 2

I observed, and took a picture of, a container with a hazardous waste label, marked with the words, "D001" and "Ethyl Ketone, Toluene" (Picture 12, Container 2). I observed that the label was not marked with the accumulation start date, and I took a Picture of the label (Picture 13).

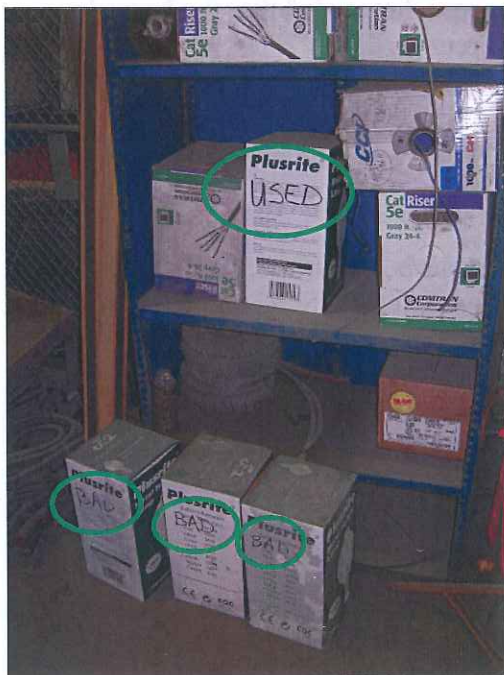
Picture #: 15
[DSCN0041]
Date: March 9, 2016
Photographer: Dan Chachakis
Location: Second Floor Maintenance Area
Subject: Universal Waste Bulbs

I observed that one box in Picture 15 was marked with the word, "Used", and that three boxes were marked with the word, "Bad." I observed that the four boxes were not marked with an accumulation start date.

At the time of the inspection, KMC’s container of lamps was not labeled with the phrase “Universal Waste-Lamps,” “Waste Lamps” or “Used Lamps.” See page 11 and Picture 15 of the enclosed inspection report.

At the time of the inspection, KMC had not marked the boxes holding universal waste – lamps with the accumulation start date, and was unable to provide records identifying the date when accumulation began for each lamp container. See page 11 and Picture 15 of the enclosed inspection report.
